CORNER RECORD

Agency Index CR-22-266

City of STOCKTON

Brief Legal Description FOUND MONUMENT SHOWN IN BOOK 27 OF MAPS AND PLATS PAGE 74

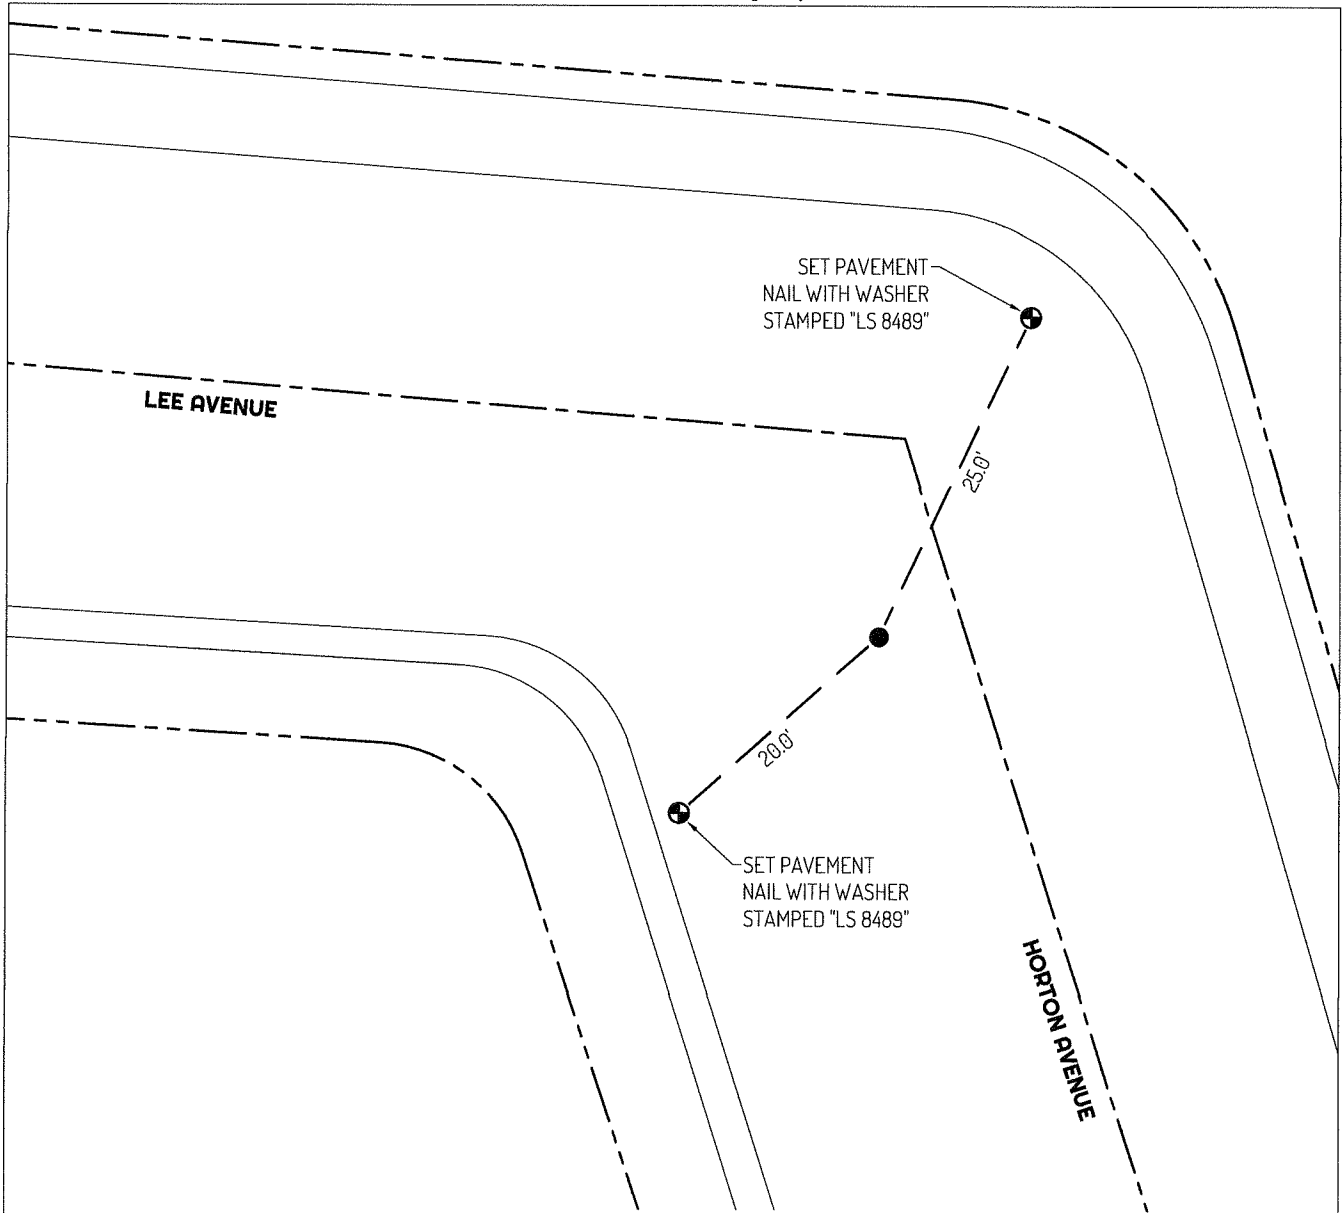
- FOUND 3/4" IRON ROD IN CENTERLINE WELL (A) NO CAP OR TAG
- ⊕— SET CONTROL POINT
- 955 ASSESSOR'S PARCEL NUMBER
- MP MAPS AND PLATS, SAN JOAQUIN COUNTY RECORDS

(A) MP 27-074
