CORNER RECORD

Agency Index CR-24-059
Document Number _____

City of STOCKTON County of SAN JOAQUIN, California
Brief Legal Description WITHIN E MAGNOLIA ST AND N CALIFORNIA ST INTERSECTION

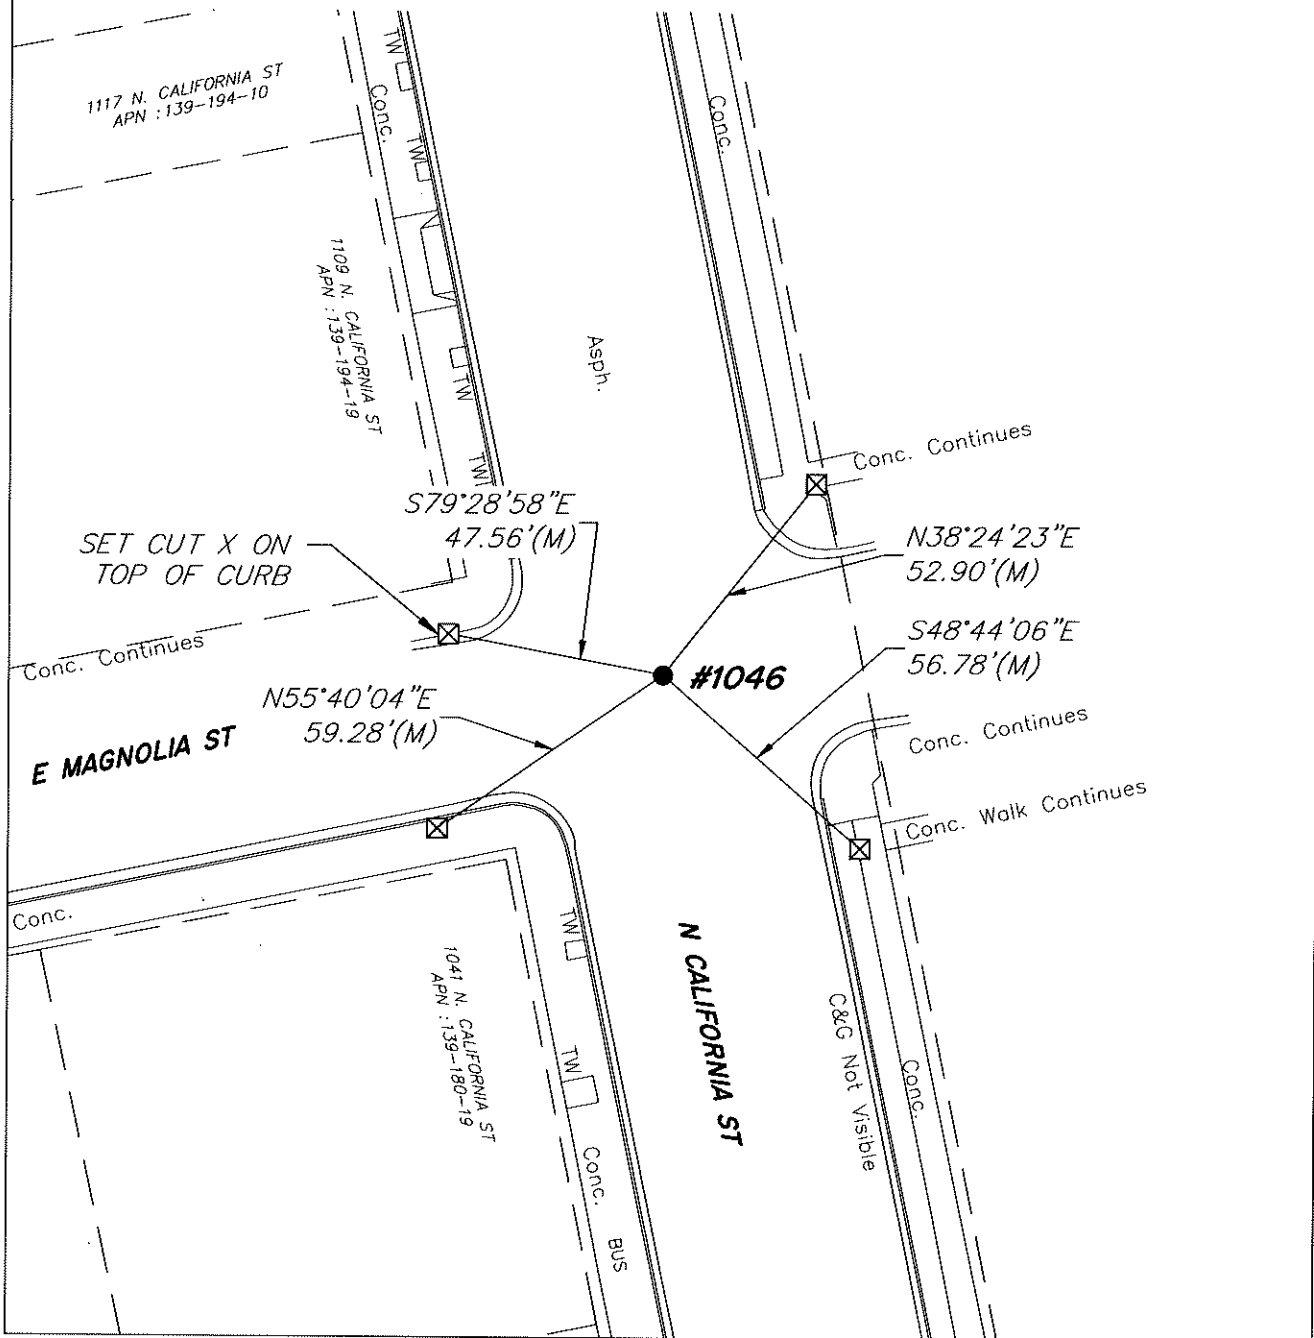
FOUND MAG NAIL IN THE AC PAVEMENT WITHIN THE INTERSECTION OF EAST MAGNOLIA STREET AND NORTH CALIFORNIA STREET. SET FOUR CUT "X" AS STRADDLERS FOR FOUND MONUMENT SHOWN ON SHEET 2. NO PREVIOUS 8771b CORNER RECORD ON FILE. CONTRACT MON #1046.
