CORNER RECORD

Agency Index CR-24-079
Document Number _____

City of STOCKTON County of SAN JOAQUIN, California
Brief Legal Description WITHIN E WASHINGTON ST AND S CALIFORNIA ST INTERSECTION

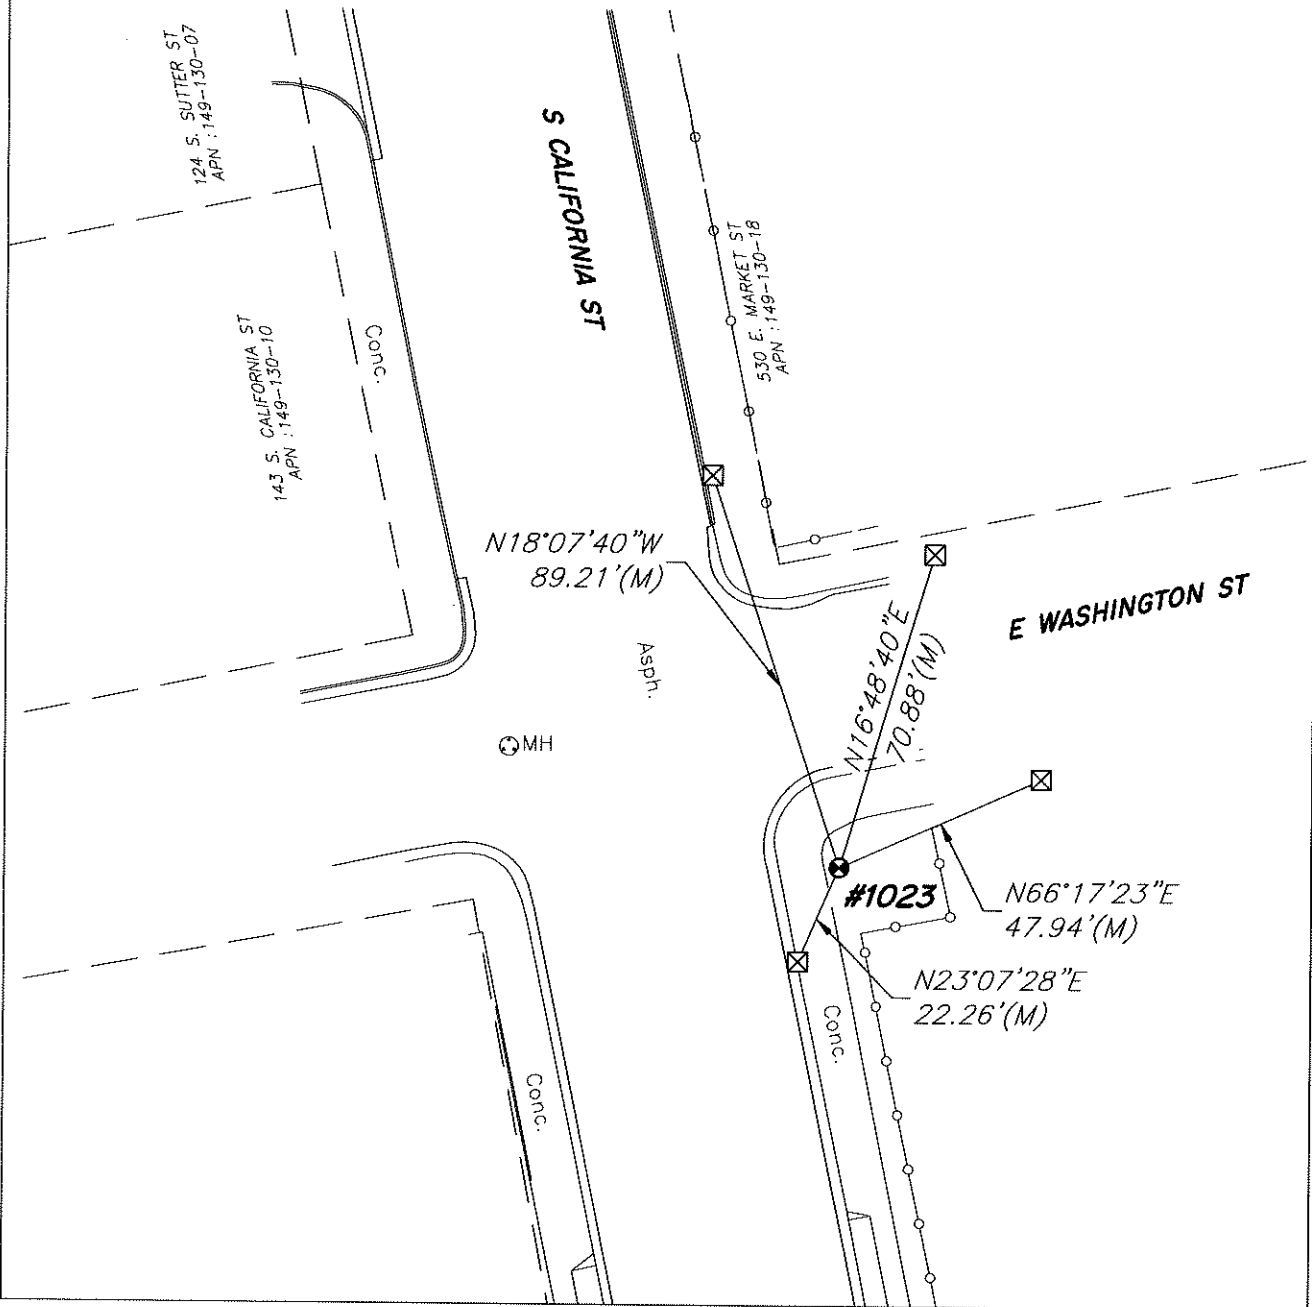
FOUND CONCRETE NAIL AND WASHER IN HUB WITHIN THE INTERSECTION OF EAST WASHINGTON STREET AND SOUTH CALIFORNIA STREET. SET FOUR CUT "X" AS STRADDLERS FOR FOUND MONUMENT SHOWN ON SHEET 2. NO PREVIOUS 8771B CORNER RECORD ON FILE. CONTRACT MON #1023.
