CORNER RECORD

Agency Index CR-24-095

City of STOCKTON County of SAN JOAQUIN, CaliforniaBrief Legal Description WITHIN E 6TH ST AND S CALIFORNIA ST INTERSECTION**CORNER TYPE****COORDINATES (Optional)**

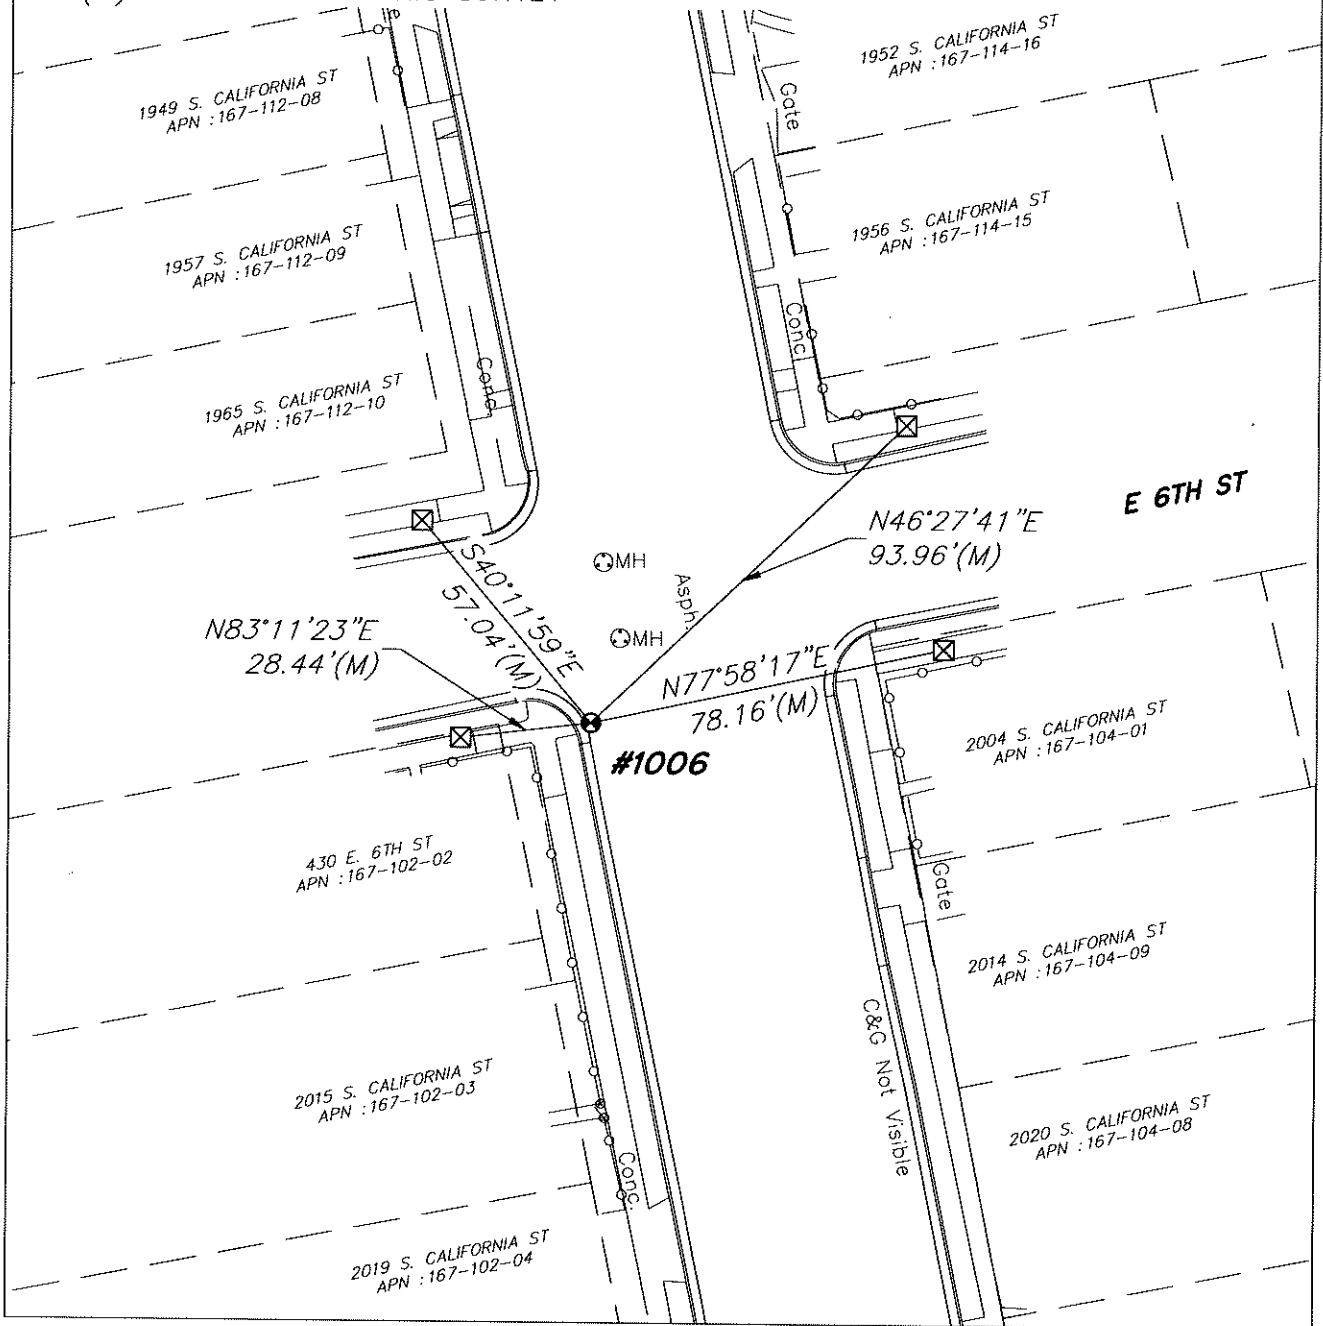
See sheet #2 for description(s):

FOUND MAG NAIL AND WASHER IN AC PAVEMENT WITHIN THE INTERSECTION OF EAST 6TH STREET AND SOUTH CALIFORNIA STREET. SET FOUR CUT "X" AS STRADDLERS FOR FOUND MONUMENT SHOWN ON SHEET 2. NO PREVIOUS 8771b CORNER RECORD ON FILE. CONTRACT MON #1006.
