CORNER RECORD

Agency Index CR-24-101
 Document Number _____

City of STOCKTON County of SAN JOAQUIN, California
 Brief Legal Description WITHIN E 8TH ST AND S CALIFORNIA ST INTERSECTION

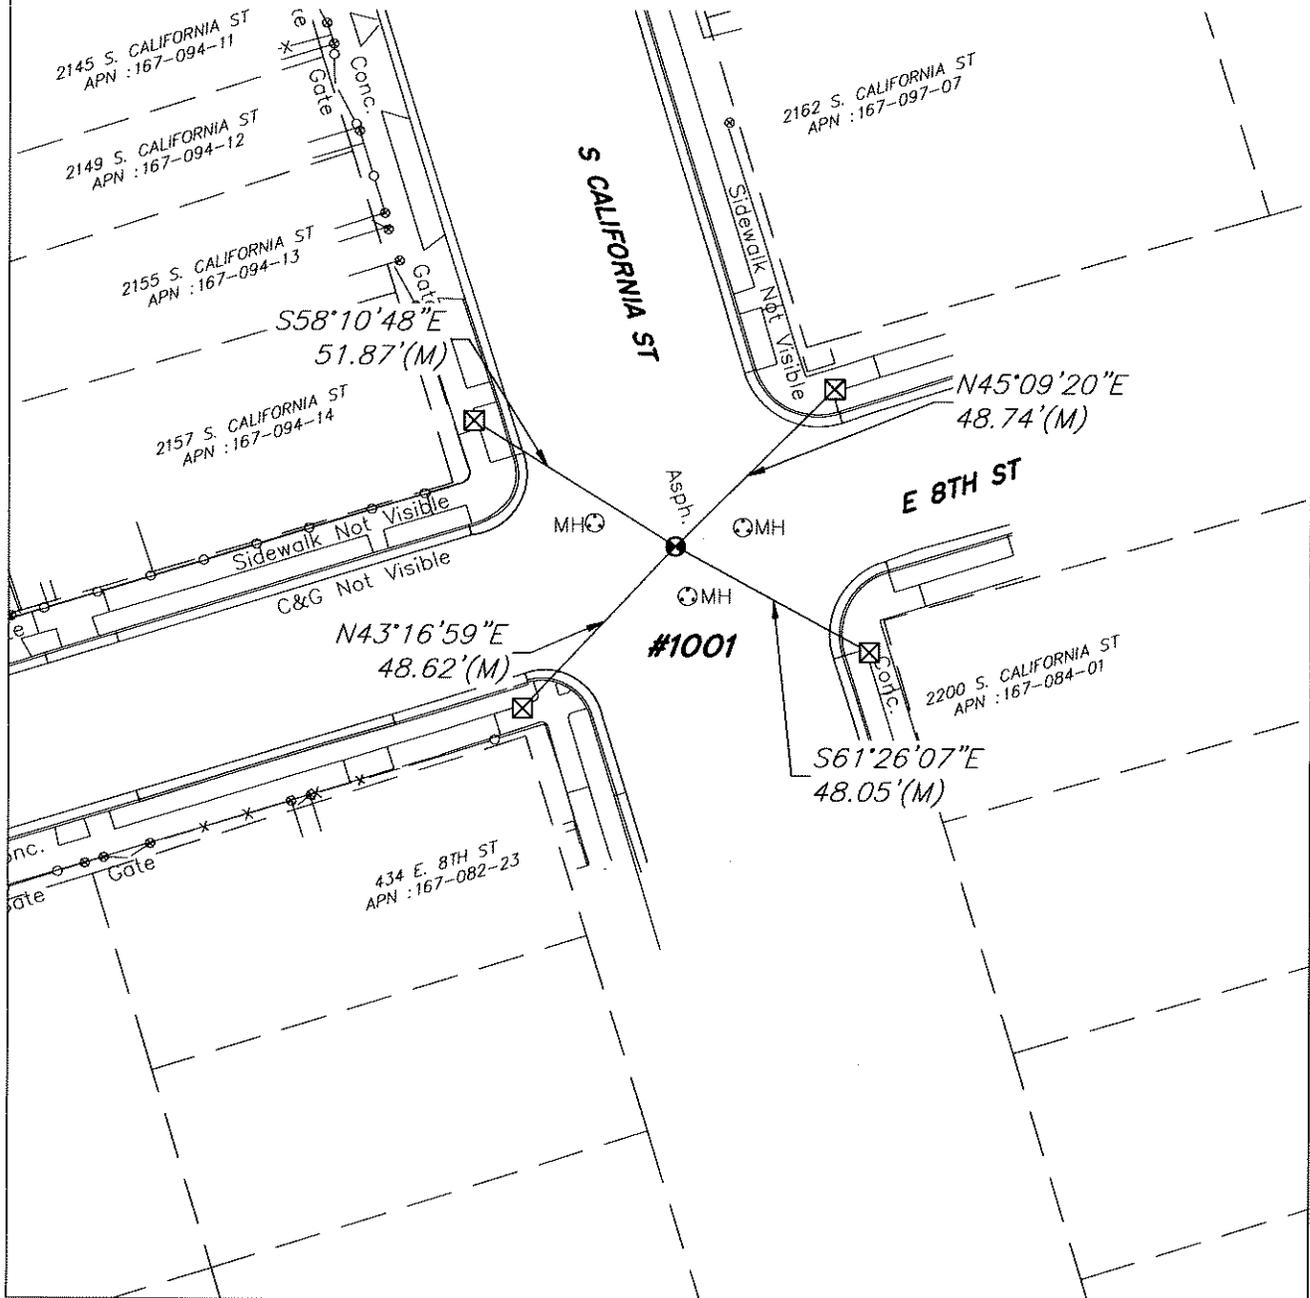
FOUND MAG NAIL AND WASHER IN AC PAVEMENT WITHIN THE INTERSECTION OF EAST 8TH STREET AND SOUTH CALIFORNIA STREET. SET FOUR CUT "X" AS STRADDLERS FOR FOUND MONUMENT SHOWN ON SHEET 2. NO PREVIOUS 8771b CORNER RECORD ON FILE. CONTRACT MON #1001.
