CORNER RECORD

CR-25-147

City of Stockton County of San Joaquin, CaliforniaBrief Legal Description Lots 1185, 1186, 1187, 1188, 1189, M&P 25-66**CORNER TYPE****COORDINATES (Optional)**

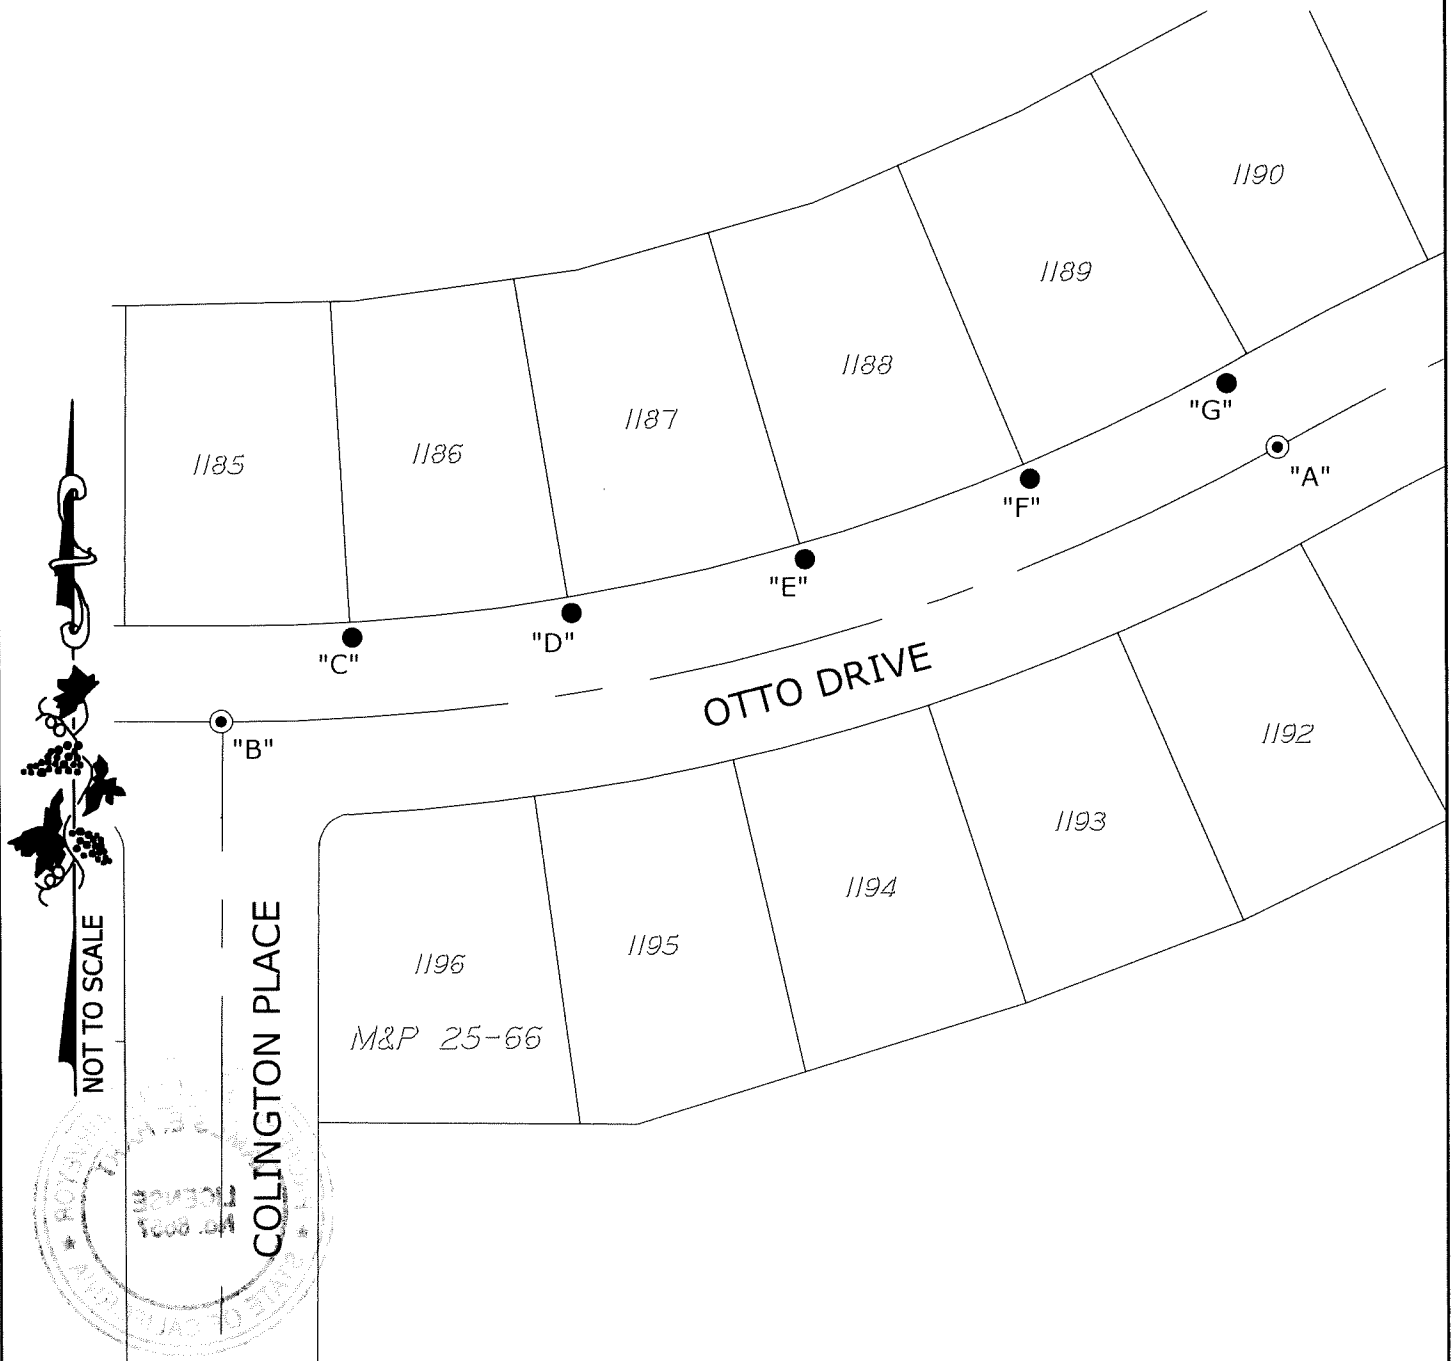
THIS CORNER RECORD IS FOR THE PURPOSE OF MONUMENT PRESERVATION. REFERENCES WERE FOUND AND/OR SET FOR FOUND MONUMENTS AS NOTED ON DIAGRAM. NO BOUNDARY ANALYSIS WAS PERFORMED. THIS CORNER RECORD DOES NOT VERIFY THE MONUMENT(S) TO BE IN THE CORRECT POSITION.

ANGLE AND DISTANCE TABLE			
BS-O-FS	ANGLE	BS DISTANCE	FS DISTANCE
A-C-B	158°51'53"	48.57'	295.01'
A-D-B	175°59'15"	114.63'	226.32'
A-E-B	177°49'10"	189.34'	151.48'
A-F-B	170°36'17"	263.92'	77.65'
A-G-B	109°52'58"	331.25'	25.48'
