# CORNER RECORD

Agency Index CR-25-205  
 Document Number \_\_\_\_\_

Brief Legal Description Sneed Road @ Bright Road  
Within Section 2, C.M. Weber Grant

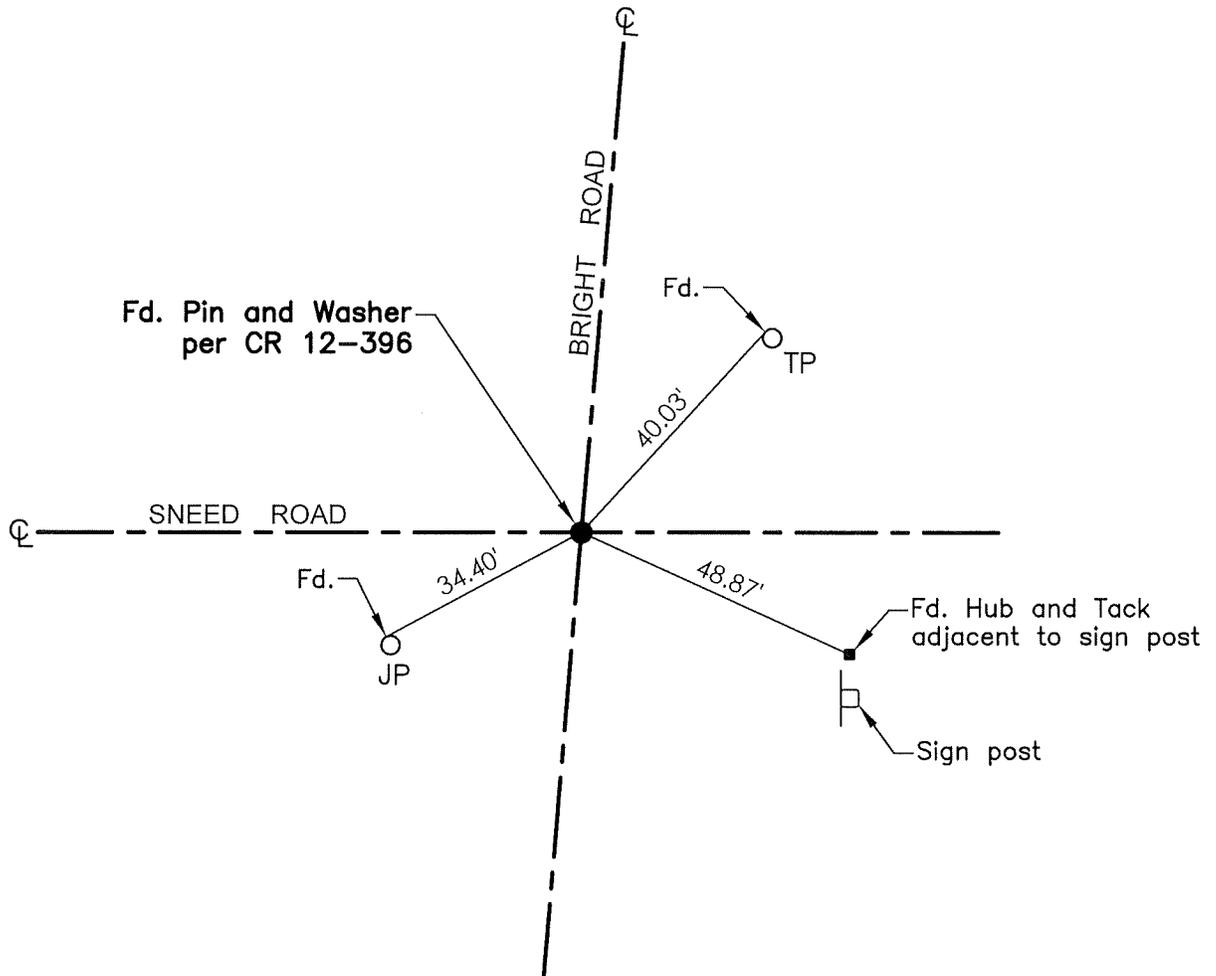
- TR=Tree
- MB=Mailbox
- BM=Bench Mark
- EP=Edge of Pavement
- YL=Yellow Line
- FH=Fire Hydrant
- CR=Corner Record
- FP=Fence Post
- JP=Joint Pole
- LP=Light Pole
- PP=Power Pole
- GP=Guy Pole
- SP=Service Pole
- TP=Telephone Pole
- S.F.N.=Searched Found Nothing
- N.T.S.=Not To Scale
- M&P=Maps & Plats
- PM=Parcel Map
- RS=Record of Survey
- FB=Field Book
- N=North
- SDI=Storm Drain Inlet
- TOC=Top of Curb
- PCC=Portland Cement Concrete

Set=Conc. Nail with Brass Washer stamped "S.J. Co.", unless otherwise noted  
 Fd.=Found Conc. Nail with Brass Washer stamped "S.J. Co.", unless otherwise noted  
 Note: Found Monuments are not tagged unless otherwise noted.

"No attempt was made to verify the Monument(s)"
