CORNER RECORD

Agency Index CR-26-115

City of STOCKTON

Brief Legal Description INTERSECTION OF BENJAMIN HOLT DR. AND GRIGSBY PLACE

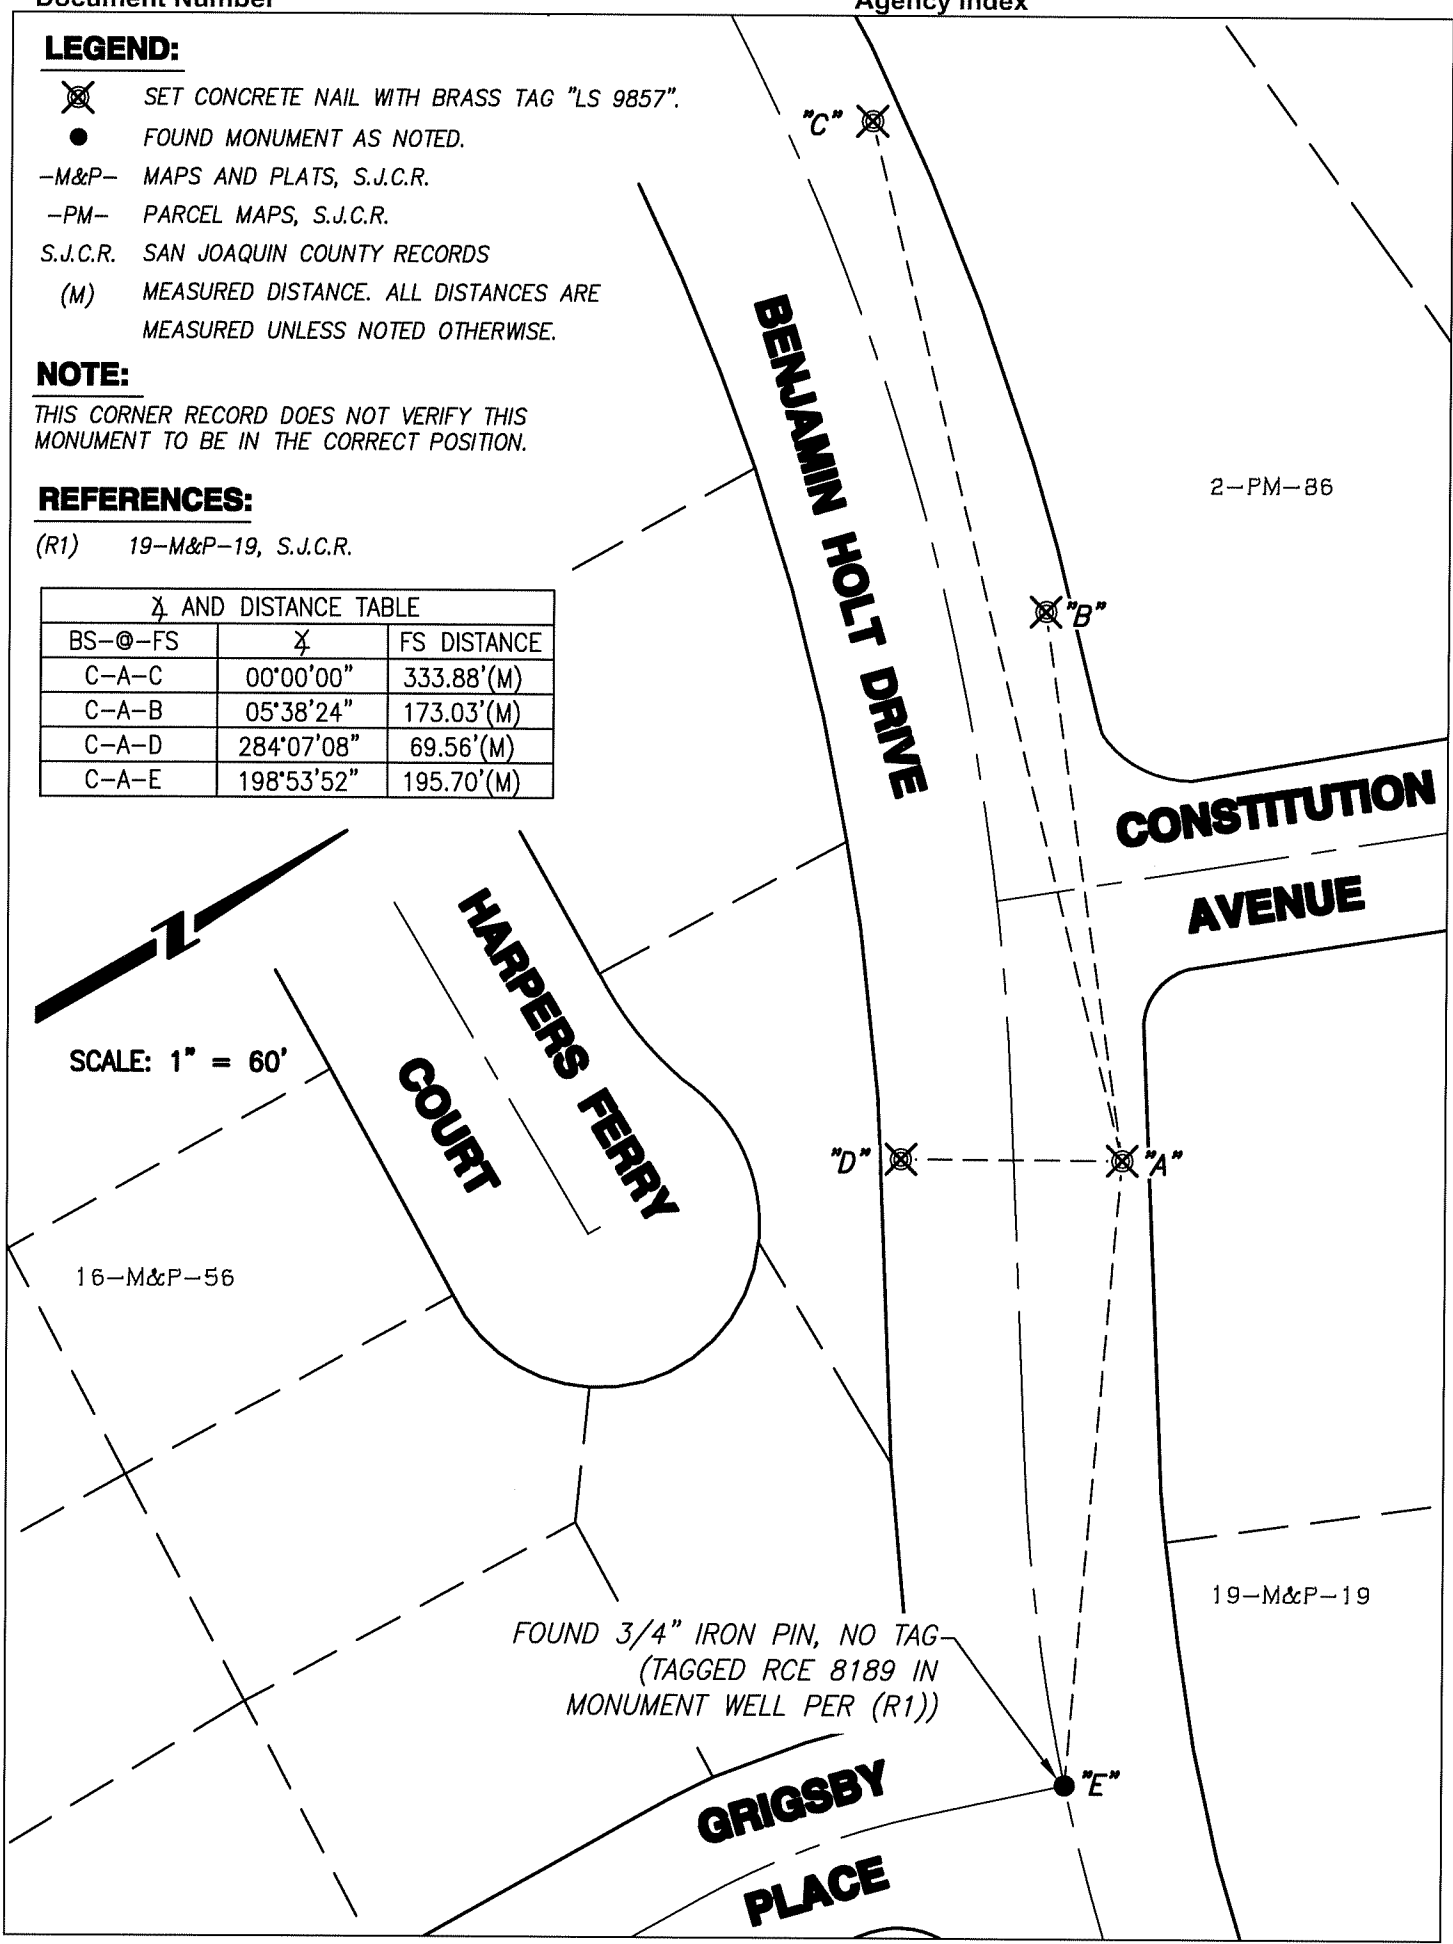
FOUND ONE (1) 3/4" IRON PIN, NO TAG; SET FOUR (4) CONCRETE NAILS WITH BRASS TAG "LS 9857" AS WITNESS CORNERS, ALL AS SHOWN ON SHEET 2.

∠ AND DISTANCE TABLE		
BS-@-FS	∠	FS DISTANCE
C-A-C	00°00'00"	333.88'(M)
C-A-B	05°38'24"	173.03'(M)
C-A-D	284°07'08"	69.56'(M)
C-A-E	198°53'52"	195.70'(M)
