CORNER RECORD

Agency Index CR-26-125
Document Number _____

City of Stockton County of San Joaquin, California
Brief Legal Description Lots 295, 296, M&P 22-75

Date of Survey February 18, 2026

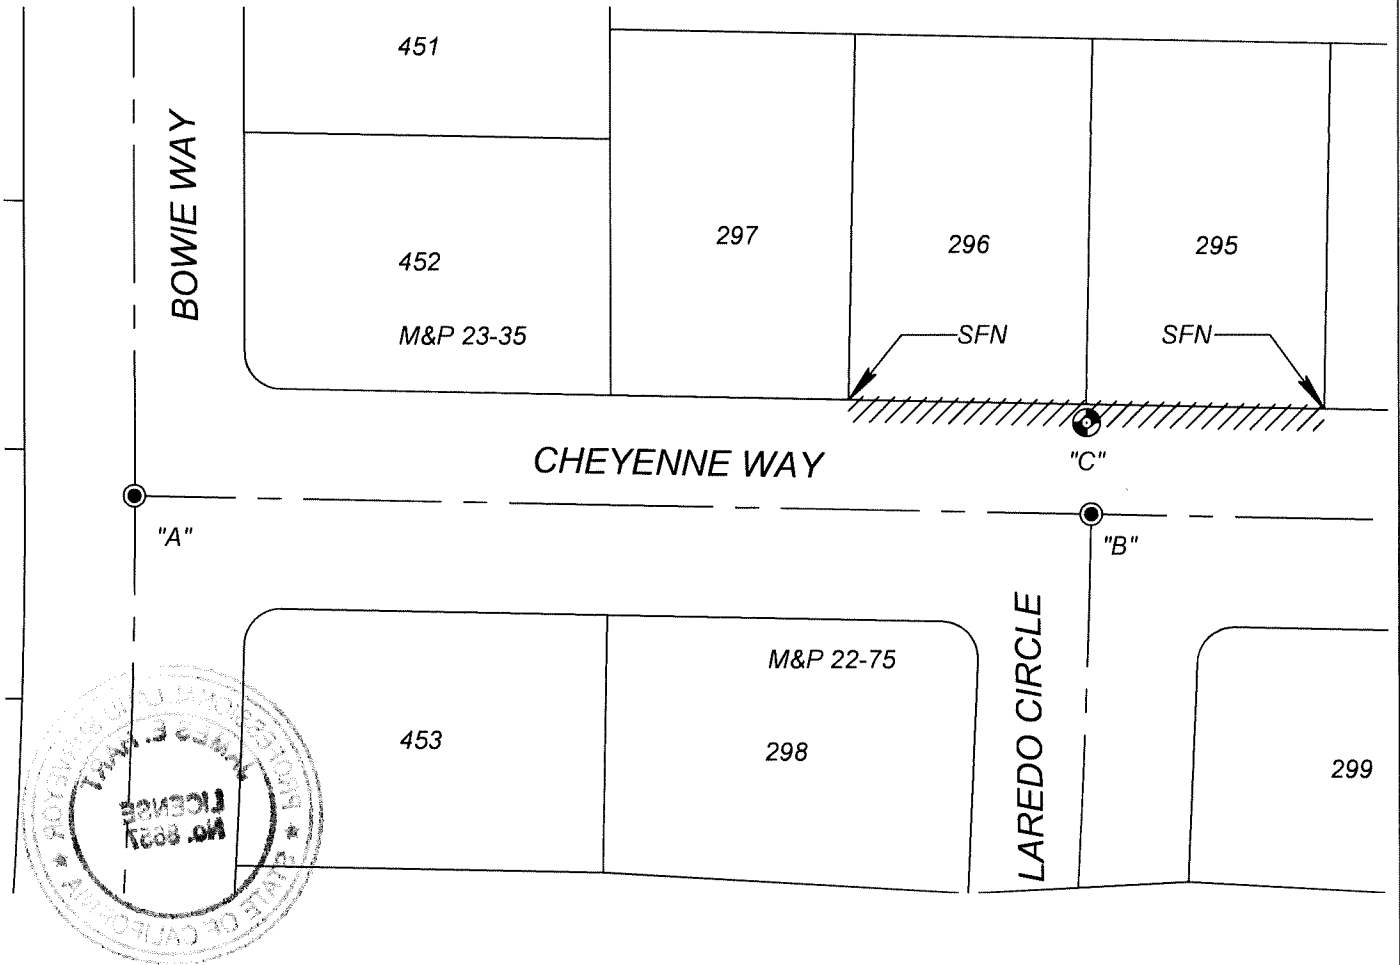
FOUND CHISELED CROSS
-

FOUND 3/4" IRON ROD TAGGED "RCE 15831" IN MONUMENT WELL

LIMITS OF CONSTRUCTION AREA

THIS CORNER RECORD IS FOR THE PURPOSE OF MONUMENT PRESERVATION. REFERENCES WERE FOUND AND/OR SET FOR FOUND MONUMENTS AS NOTED ON DIAGRAM. NO BOUNDARY ANALYSIS WAS PERFORMED. THIS CORNER RECORD DOES NOT VERIFY THE MONUMENT(S) TO BE IN THE CORRECT POSITION.

BS-O-FS	ANGLE	BS DISTANCE	FS DISTANCE
A-C-B	88°22'20"	260.98'	25.03'
