CORNER RECORD

Agency Index CR-26-142

City of STOCKTON

Brief Legal Description CAYUGA DRIVE BETWEEN HUDSON DRIVE AND CAYUGA COURT

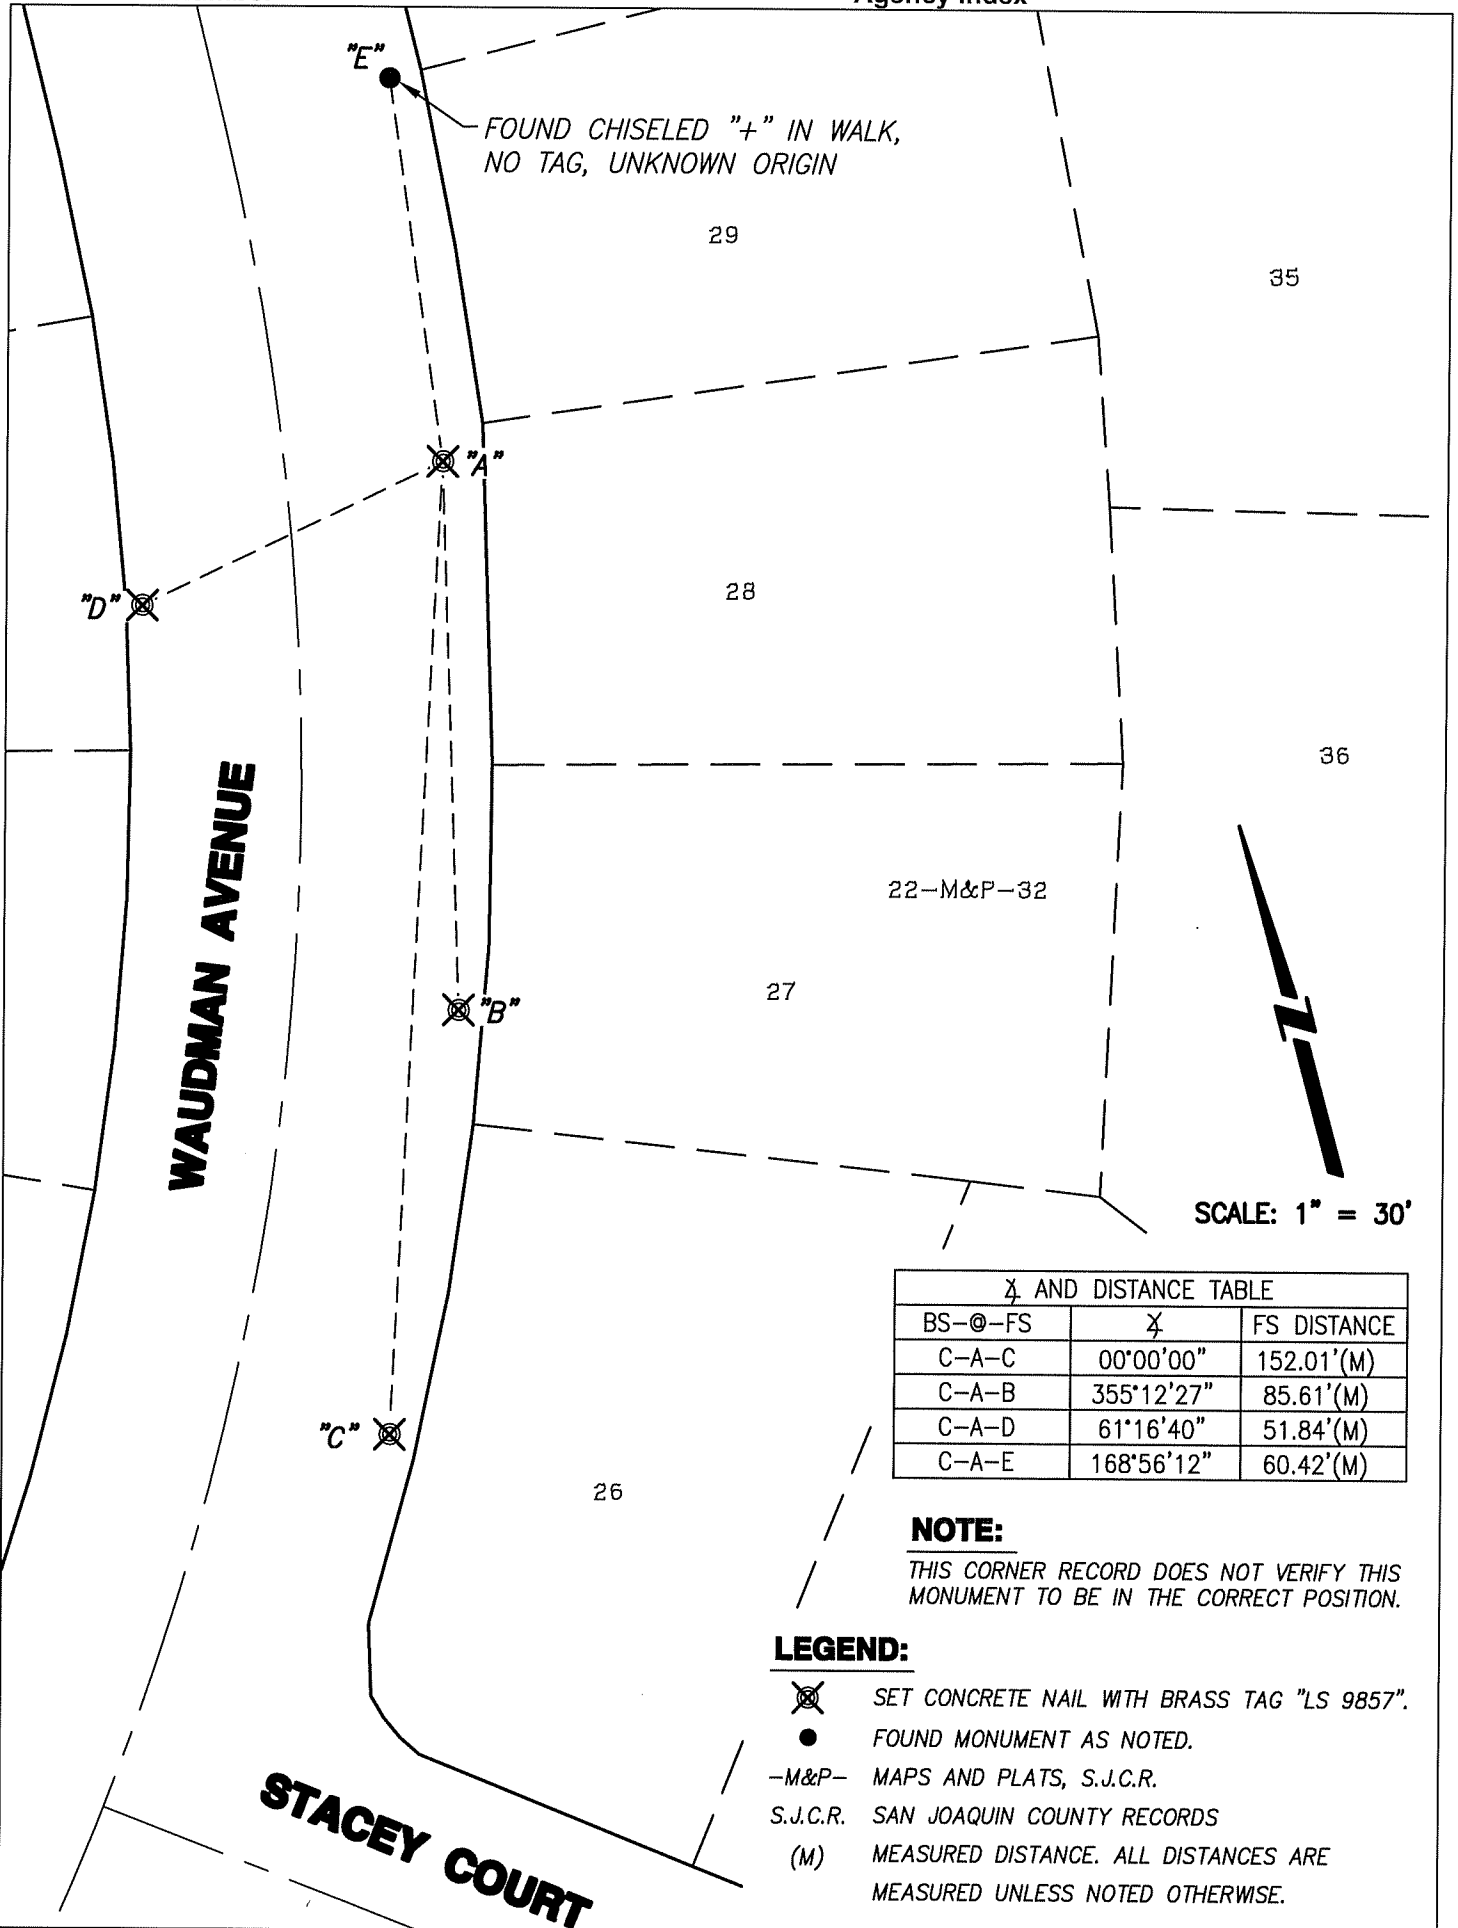
FOUND ONE (1) CHISELED "+" IN WALK, NO TAG; SET FOUR (4) CONCRETE NAILS WITH BRASS TAG "LS 9857" AS WITNESS CORNERS, ALL AS SHOWN ON SHEET 2.

FOUND CHISELED "+" IN WALK,
NO TAG, UNKNOWN ORIGIN

X AND DISTANCE TABLE		
BS-@-FS	X	FS DISTANCE
C-A-C	00°00'00"	152.01'(M)
C-A-B	355°12'27"	85.61'(M)
C-A-D	61°16'40"	51.84'(M)
C-A-E	168°56'12"	60.42'(M)
